Bristol Avon Rivers Trust

By Brook Catchment Fluvial Audit:

Source to confluence River Avon to include tributaries

March 2015

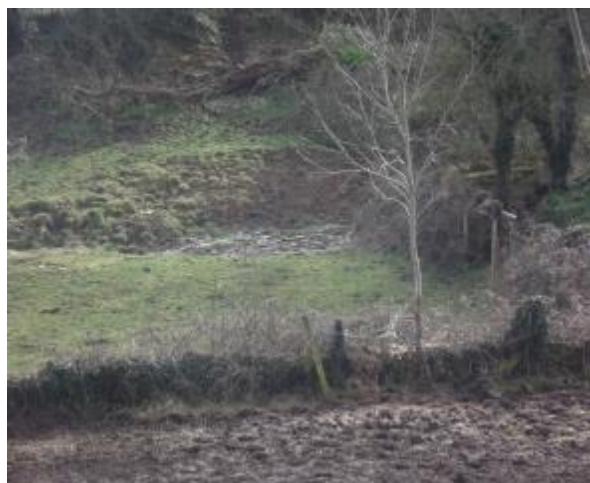
E: Poaching by livestock.

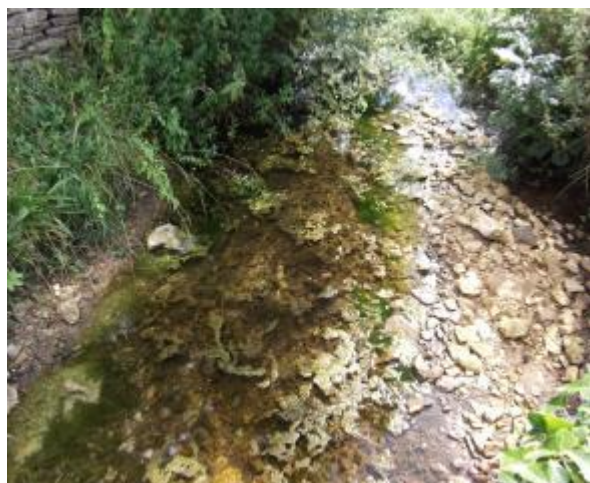
F: Algae covered sediment.

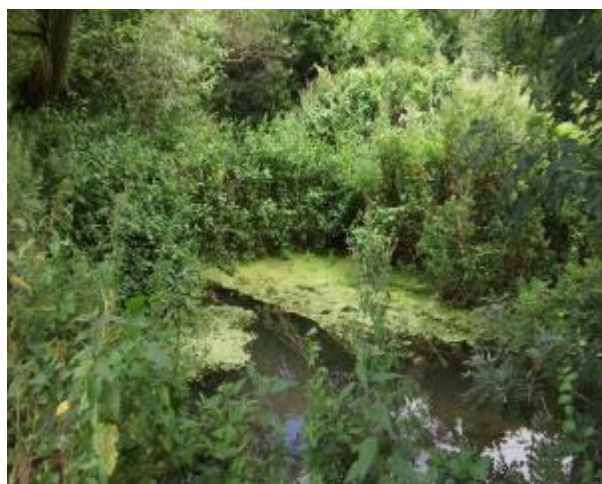
G: Channel choked by dense vegetation growth.

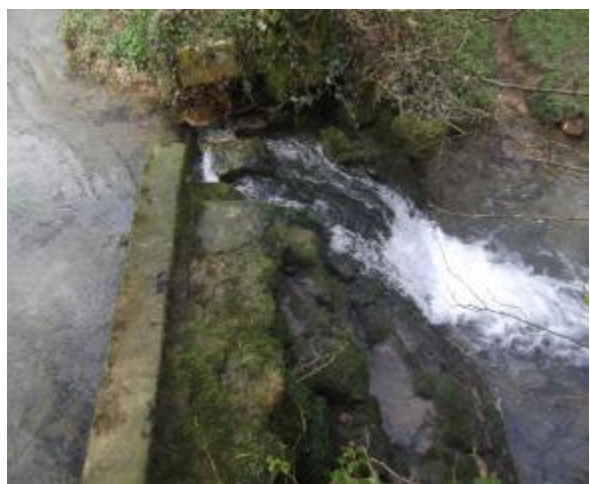
H: In-channel structures.

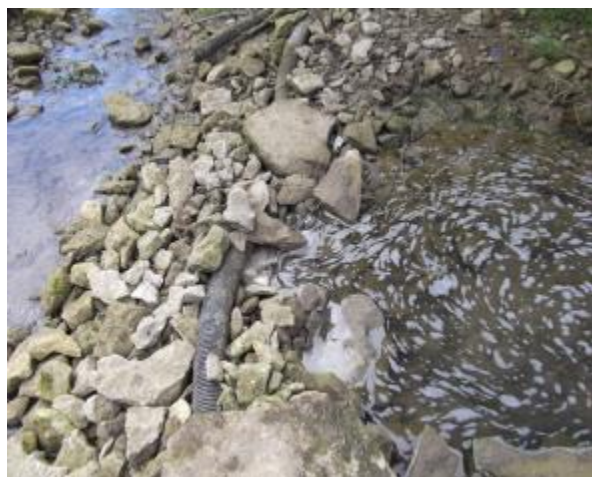
C: Domestic outputs of phosphate

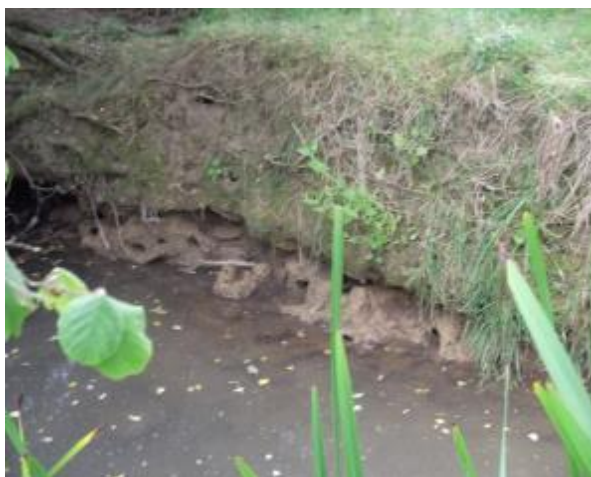
D: Possible presence of American signal crayfish causing bank erosion

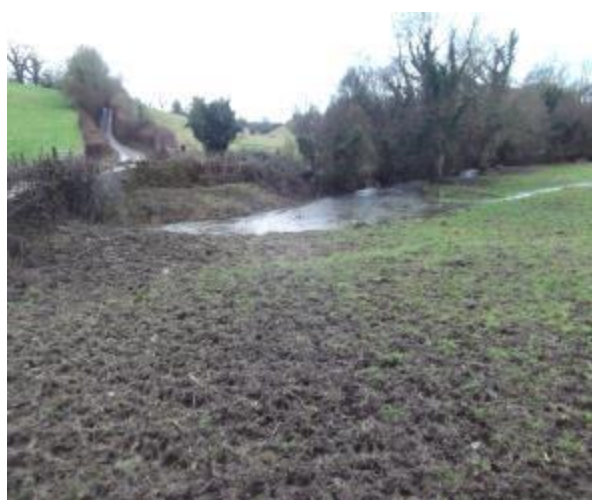
E: Heavily poached banks

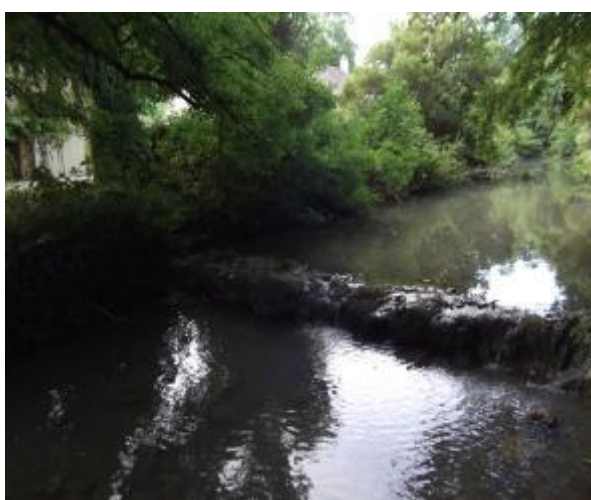
H: Over-widened channel

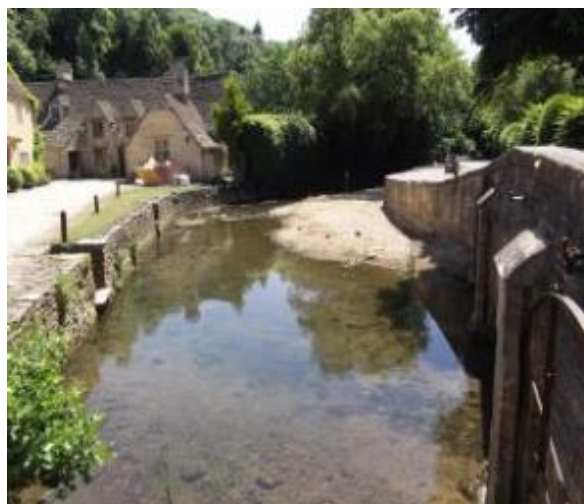
C: Over-widened channel in residential areas.

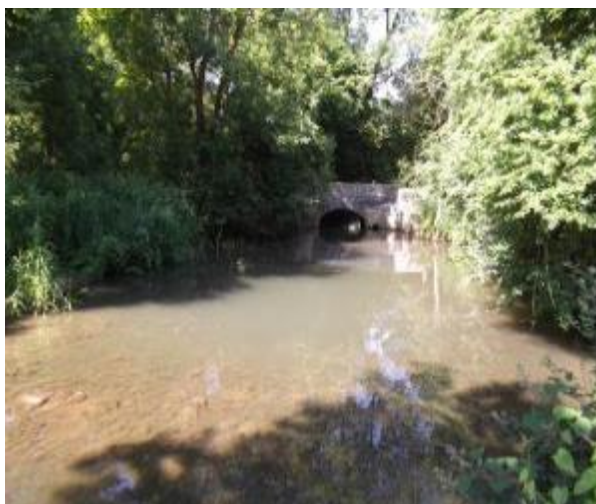
D: Considerable silt deposition on substrate.

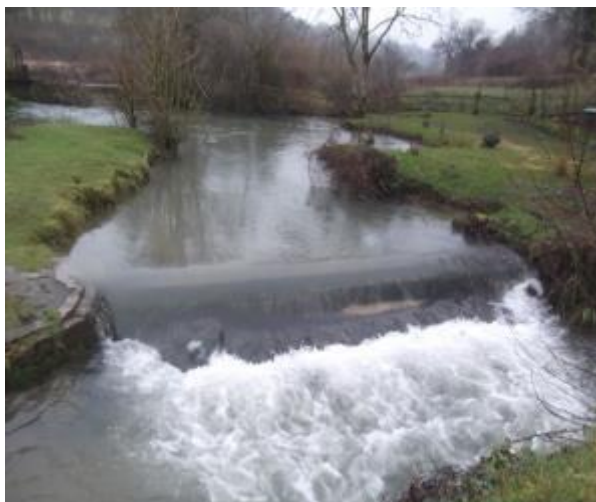
F: A large number of in-stream structures.

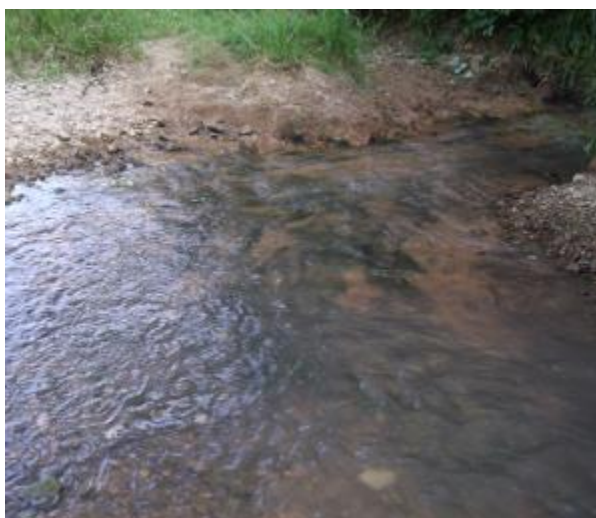
H: Considerable algal growth on substrate.

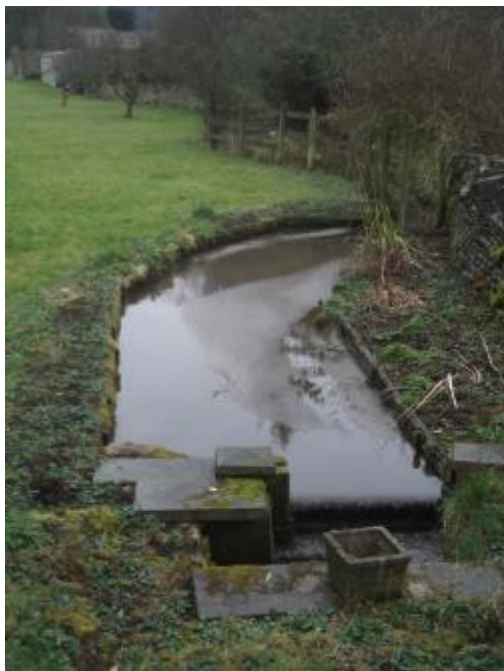
E: Short sections of heavily modified channel.

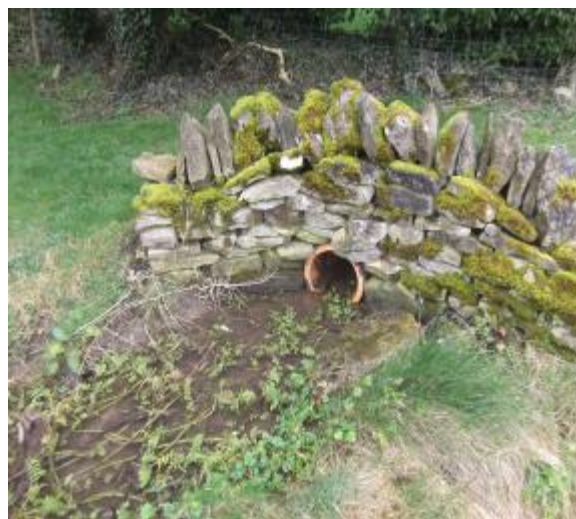
F: Short sections of culverting.

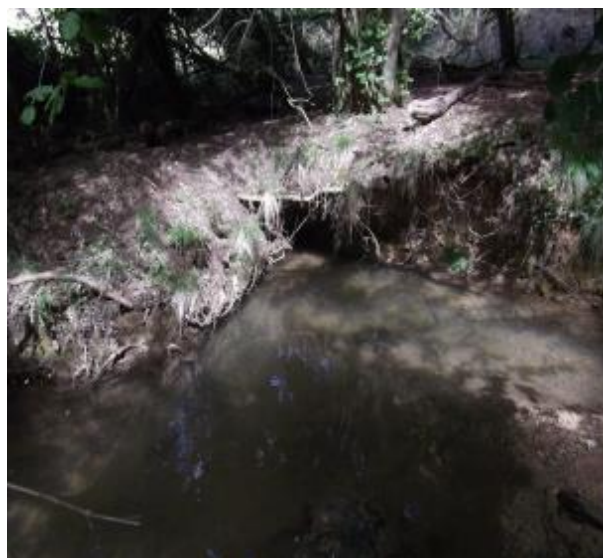
C: Eroding left-hand and right-hand banks.

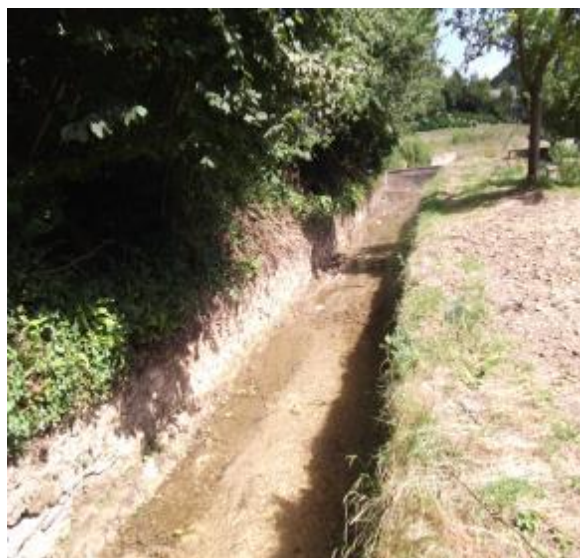
D: Over abstraction, including water use for amenity ponds & lakes.

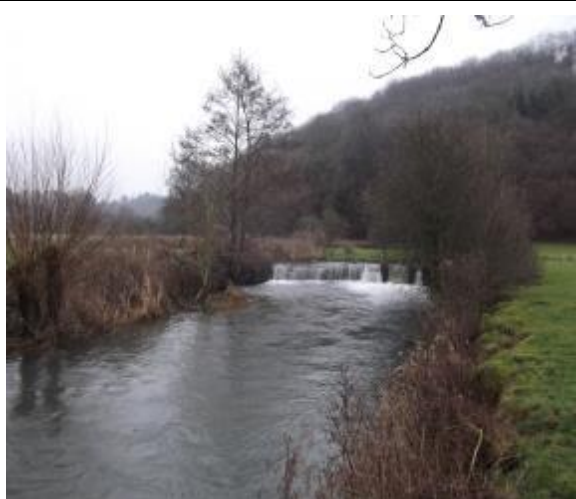
<p>A: In-stream structures are an issue for fish passage.</p>

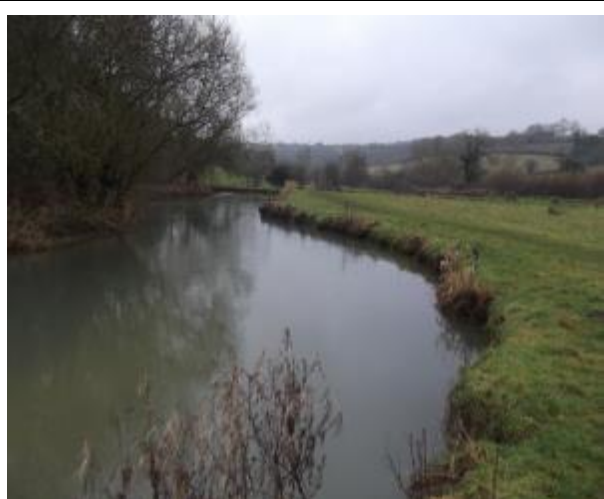
<p>B: Channel impoundment with no perceptible flow.</p>

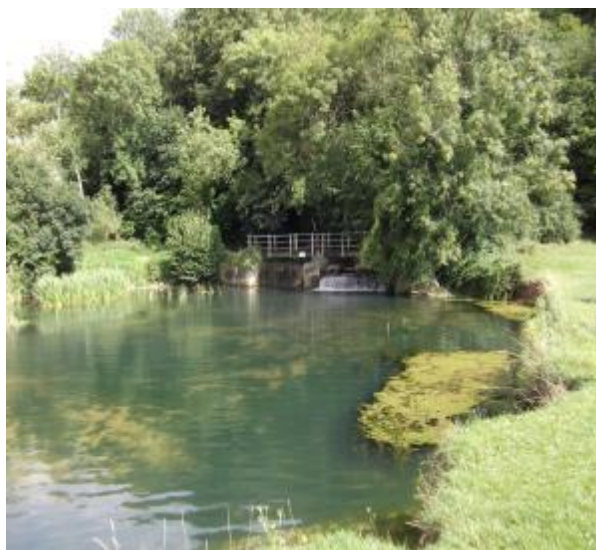
D: Large algal blooms cover sediment and form on the surface during the summer.

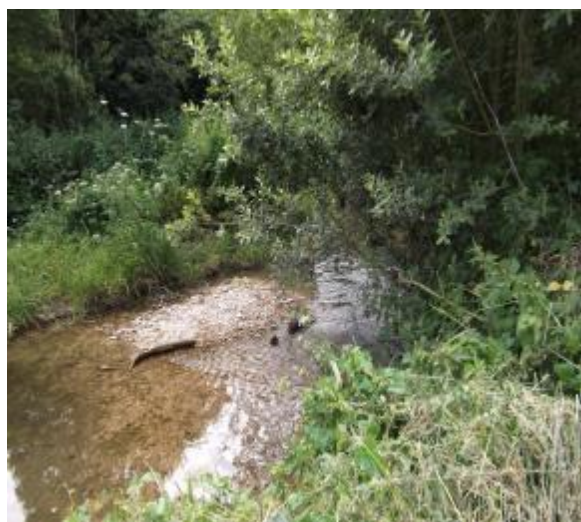
E: Silt covering potential spawning gravels.

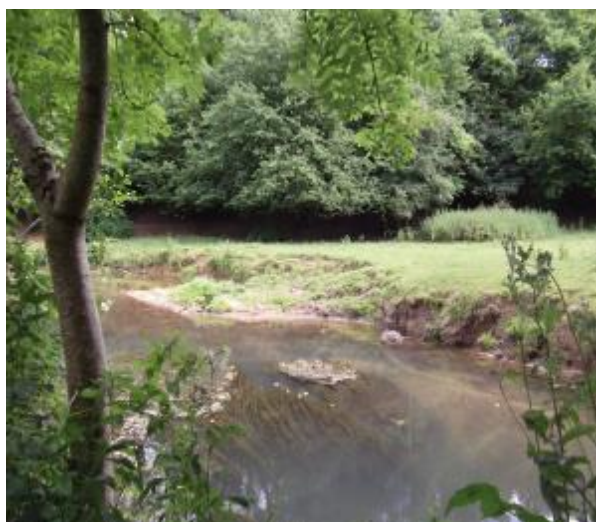
F: Bank collapse exasperated by poaching from livestock.

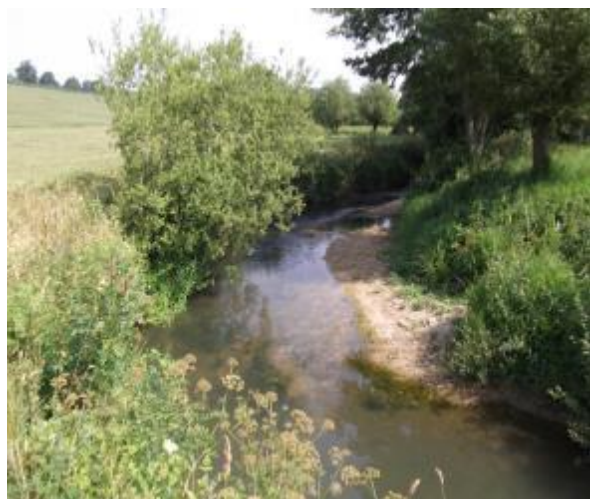
E: Siltation of potential spawning gravels.

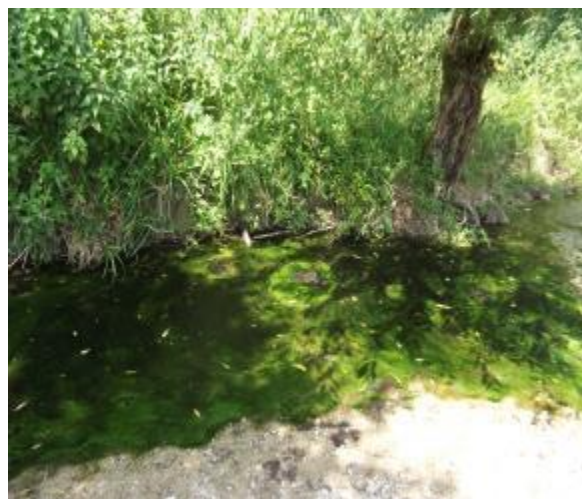
F: Algae covered sediment and signs of eutrophication.

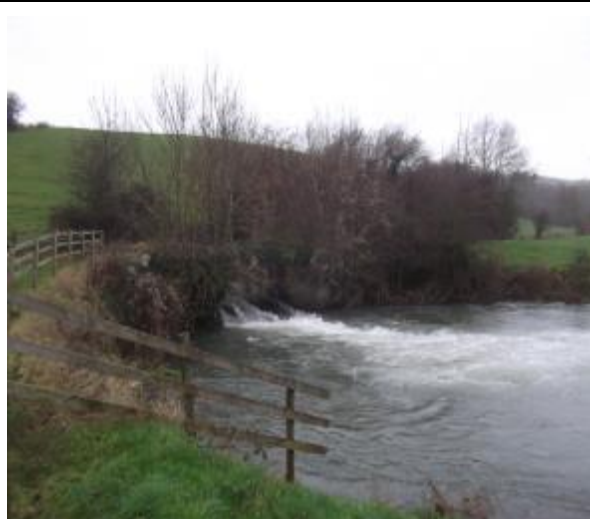
G: In-channel structures have lead to over-deepened channels and are an obstruction to fish passage.

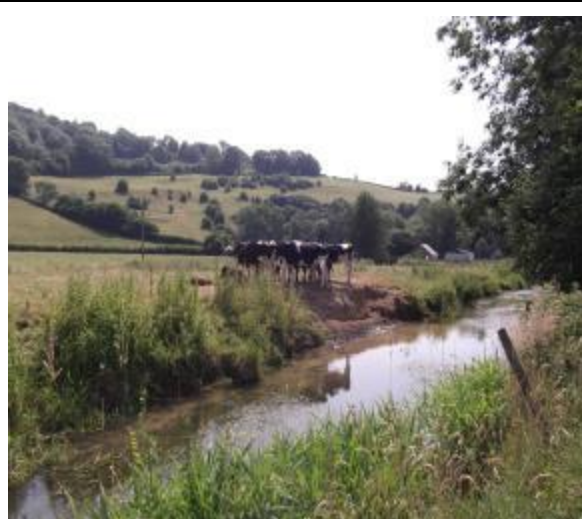
H: Engineered straight channel.

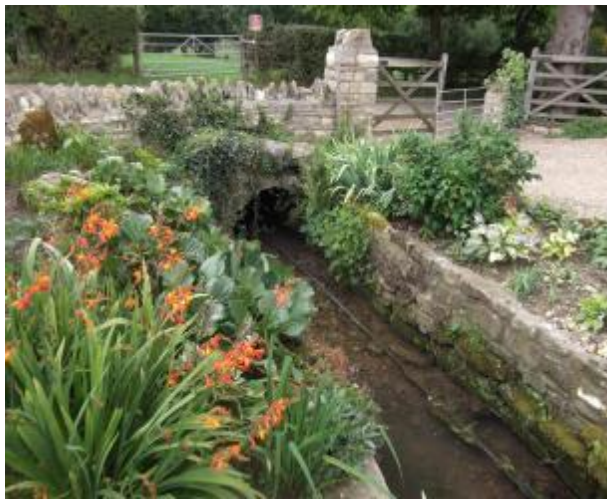
<p>B: Heavily modified channel through Saltbox Farm.</p>

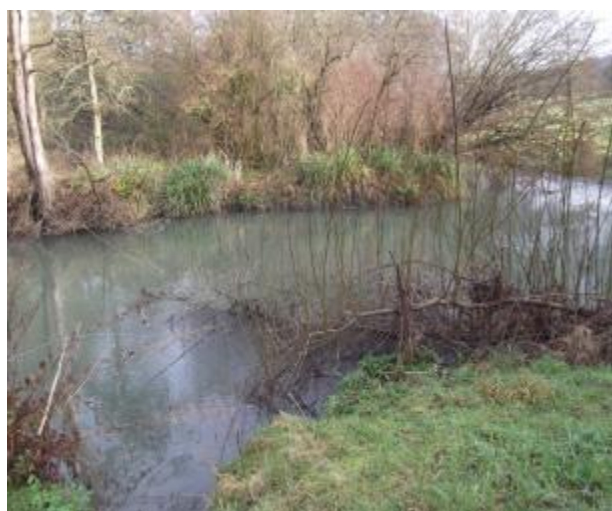
C: Impoundment downstream of Box Bridge due to in-channel structures.

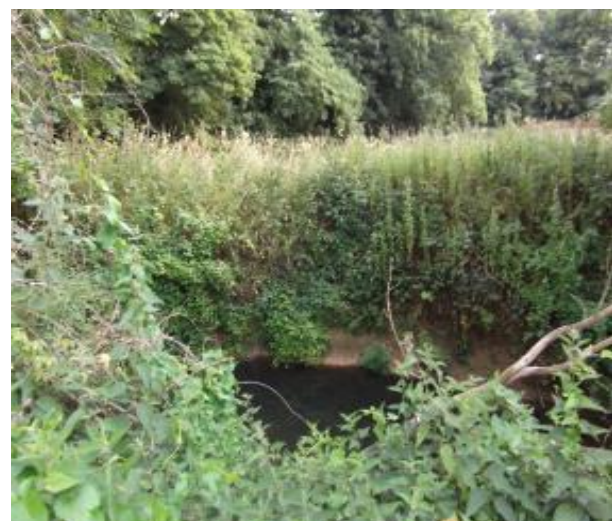
E: Over-deepened steep banks.

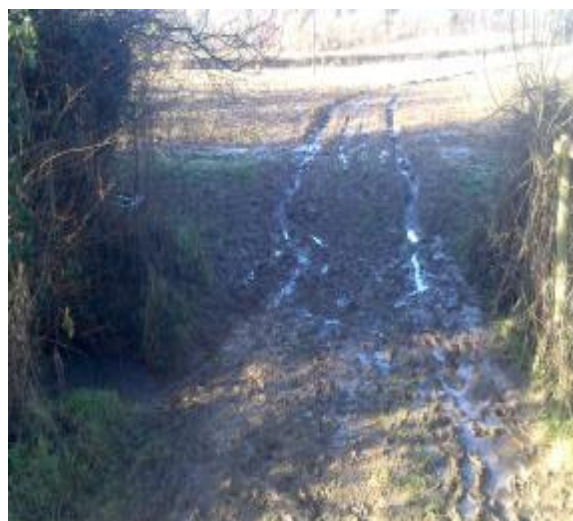
D: Agricultural run-off.

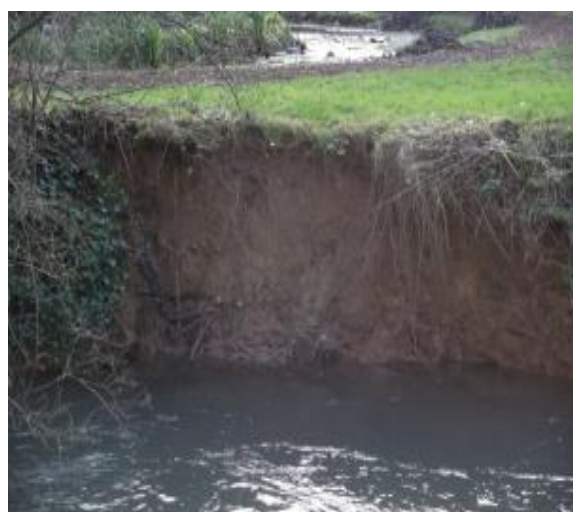
F: Steeply eroding banks.

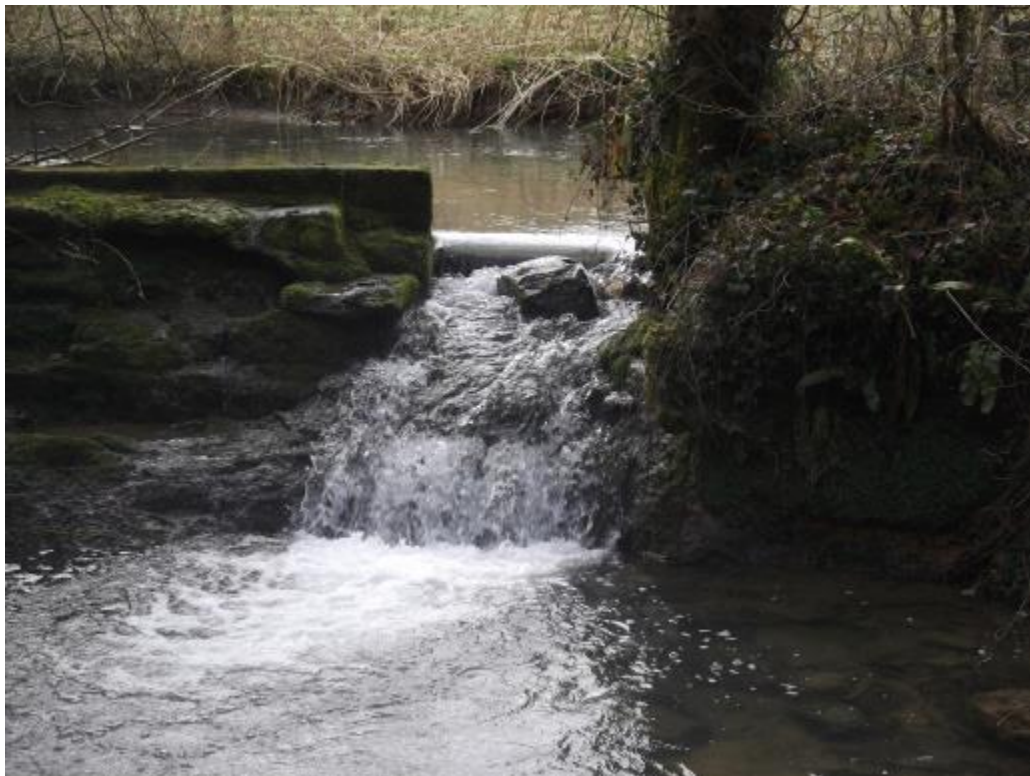
Project	By Brook catchment	River	By Brook
Reach Number	1	Recorder	MH
Date	29/12/2014	NGR	383599,178866
Category	E	Type	BAR-we
Description	Straight drop weir approximately 0.8m high and 0.8m wide.		
Land Use	LHB: lay-by/ trees.	RHB: improved/ semi-improved grassland.	
Comments	A straight drop weir of approximately 0.8m in height and 0.8m in width, situated upstream of Gatcombe Mill. The weir is only likely to be passable to migratory fish in medium and high flows.

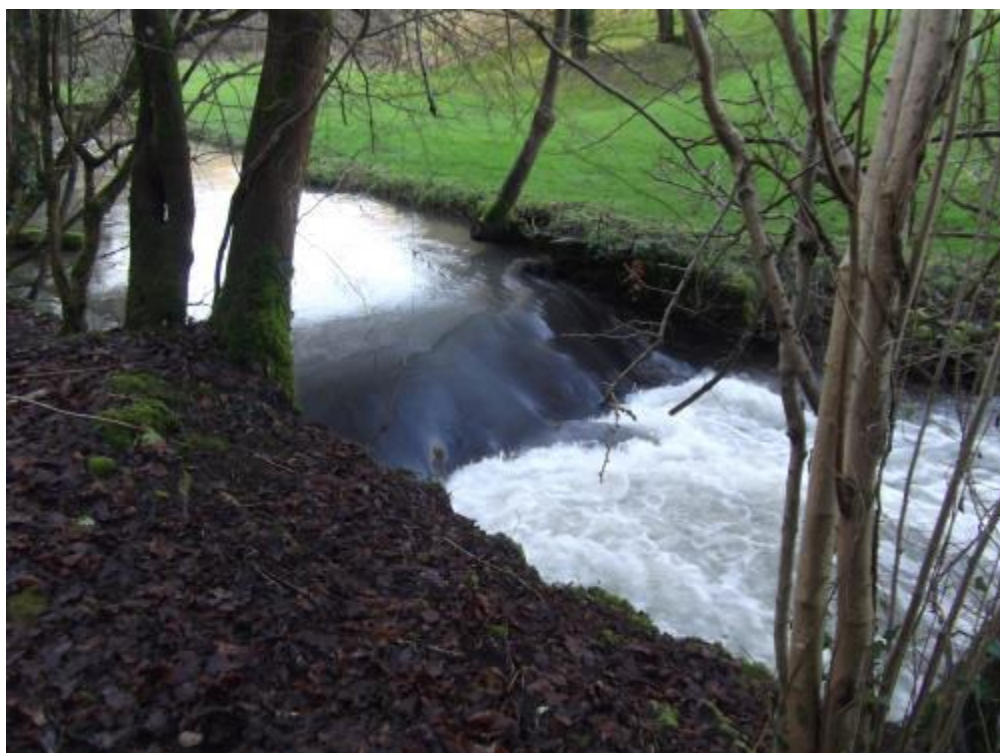
Table 23 Potential barriers to fish migration: Reach 2, NGR 383456,177586.

Project	By Brook catchment	River	Broadmead Brook
Reach Number	2	Recorder	MH
Date	03/01/2015	NGR	383456,177586
Category	E	Type	BAR-we
Description	Broad crested weir approximately 2.3m high and 5m wide.		
Land Use	LHB: Residential		RHB: Public track/ woodland
Comments	<p>A broad crested weir of approximately 2.3m in height and 5m in width, situated downstream of Nettleton Mill, near Castle Combe. The weir is only likely to be passable to migratory fish at high flows.</p>

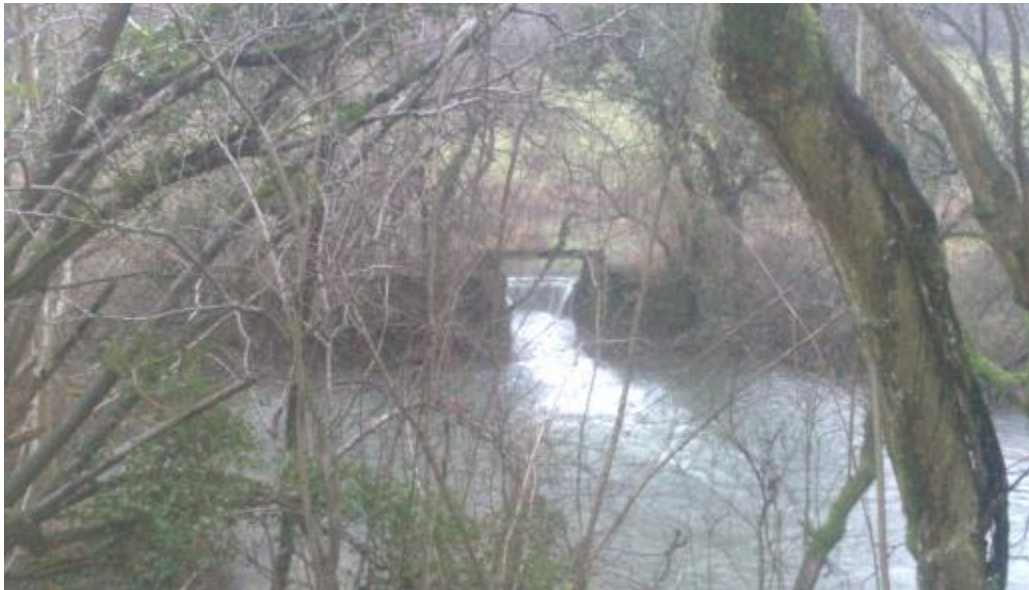
Table 24 Potential barriers to fish migration: Reach 3, NGR 384 056,176 723.

Project	By Brook catchment	River	By Brook
Reach Number	3	Recorder	MH
Date	08/01/2015	NGR	384 056,176 723
Category	E	Type	BAR-we
Description	Straight drop weir approximately 3.5m high and 3m wide.		
Land Use	LHB: Improved/ semi-improved grassland	RHB: Improved/ semi-improved grassland	
Comments	<p>A straight drop weir of approximately 3.5m in height and 3m in width, situated downstream of Brook House, Castle Combe. The weir is unlikely to be passable to any migratory fish, even in high flows.</p>

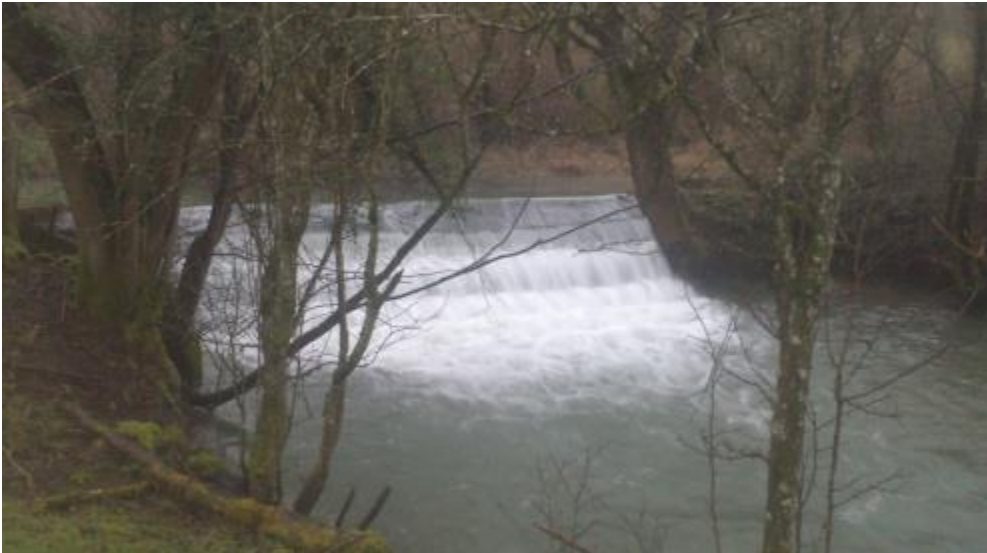
Table 25 Potential barriers to fish migration: Reach 3, NGR 384104,176585.

Project	By Brook catchment	River	By Brook
Reach Number	3	Recorder	MH
Date	08/01/2015	NGR	384104,176585
Category	E	Type	BAR-we
Description	Stepped weir approximately 3.5m high and 13m wide.		
Land Use	LHB: Improved/ semi-improved grassland	RHB: Improved/ semi-improved grassland	
Comments	A straight stepped weir of approximately 3.5m in height and 13m in width, situated downstream of Brook House, Castle Combe. The weir is unlikely to be passable to any migratory fish, even in high flows.

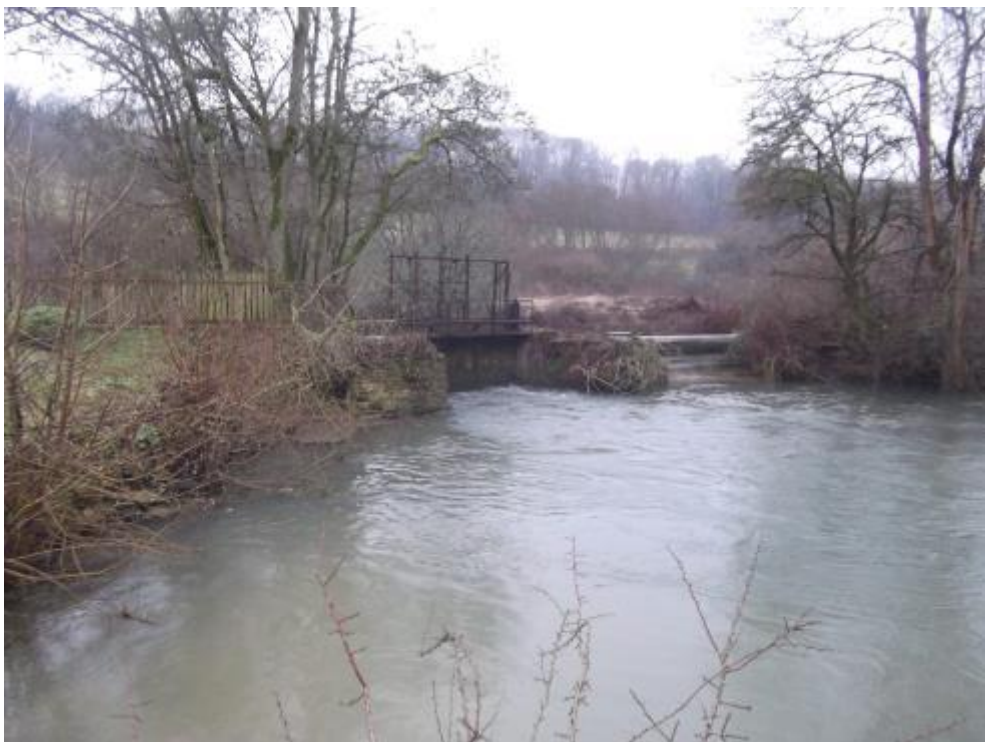
Table 26 Potential barriers to fish migration: Reach 3, NGR 384165,176151.

Project	By Brook catchment	River	By Brook
Reach Number	3	Recorder	MH
Date	08/01/2015	NGR	384165,176151
Category	E	Type	BAR-we
Description	Stepped weir approximately 3m high and 8m wide. Also sluice gates.		
Land Use	LHB: Improved/ semi-improved grassland	RHB: Residential garden.	
Comments	<p>A straight stepped weir of approximately 3m in height and 8m in width, situated at Colham Mill, near Castle Combe. The weir is only likely to be passable to migratory fish at high flows.</p>

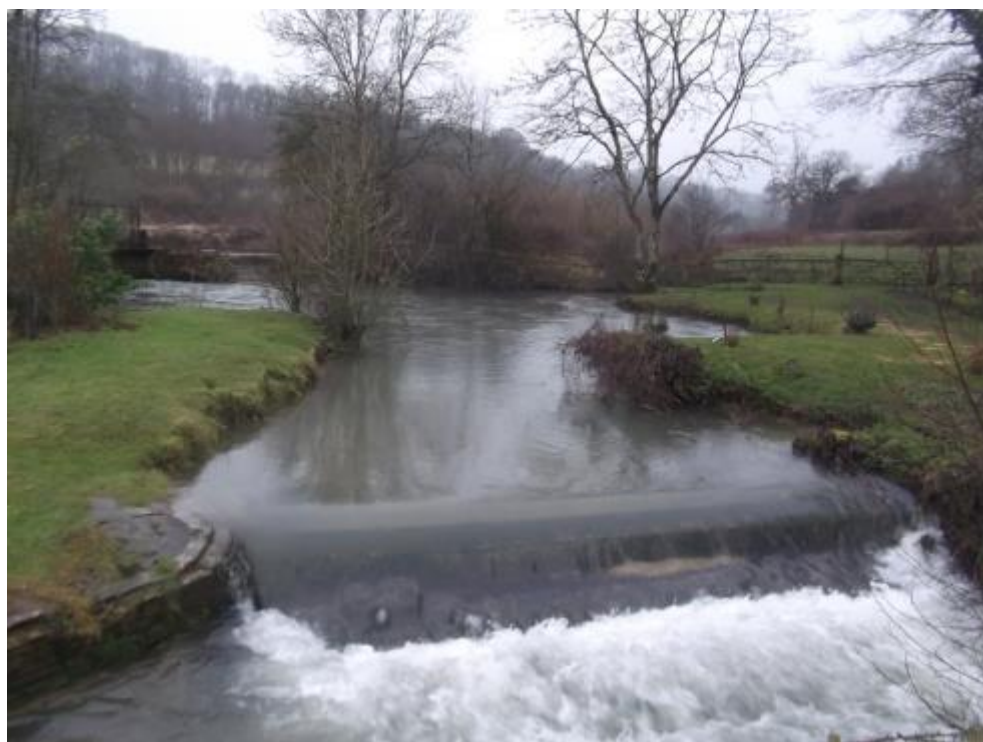
Table 27 Potential barriers to fish migration: Reach 3, NGR 384169,176159.

Project	By Brook catchment	River	By Brook
Reach Number	3	Recorder	MH
Date	08/01/2015	NGR	384169,176159
Category	E	Type	BAR-we
Description	Stepped weir approximately 2m high and 10m wide.		
Land Use	LHB: Residential garden	RHB: Residential garden	
Comments	<p>A straight stepped weir of approximately 2m in height and 10m in width, situated at Colham Mill, Castle Combe. The weir is only likely to be passable to migratory fish at high flows.</p>

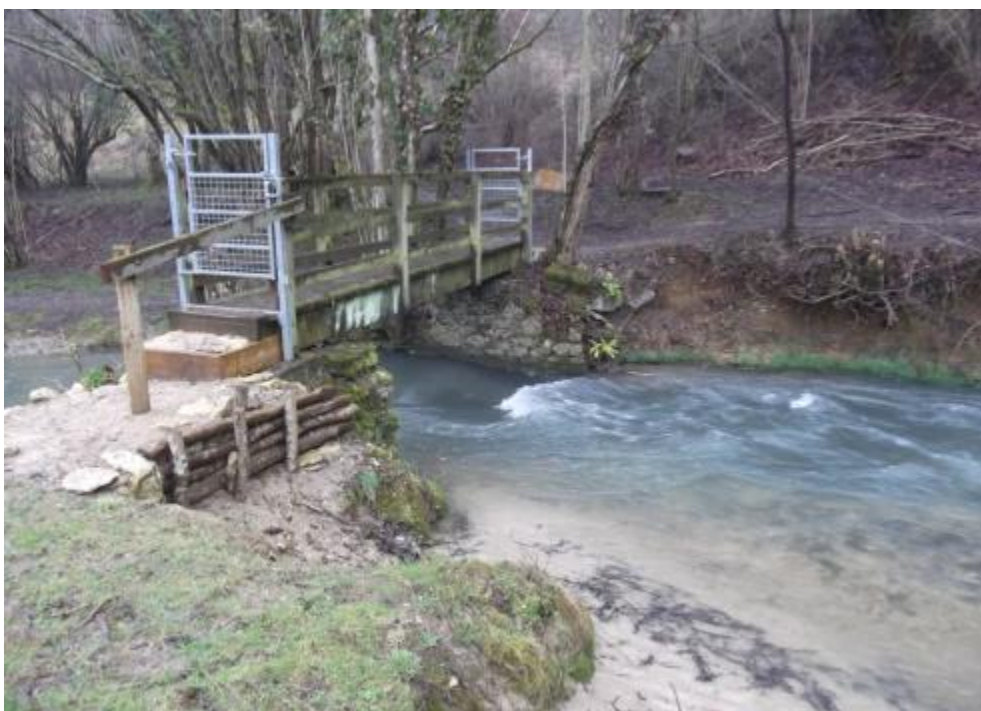
Table 28 Potential barriers to fish migration: Reach 3, NGR 384577,175985.

Project	By Brook catchment	River	By Brook
Reach Number	3	Recorder	MH
Date	08/01/2015	NGR	384577,175985
Category	E	Type	BAR-we
Description	Broad crested weir approximately 1m high and 4m wide.		
Land Use	LHB: Deciduous woodland	RHB: Improved/ semi-improved grassland	
Comments	<p>A broad crested weir of approximately 1m in height and 4m in width, situated downstream of Colham Mill, near Castle Combe. The weir is likely to be passable to migratory fish in moderate and high flows.</p>

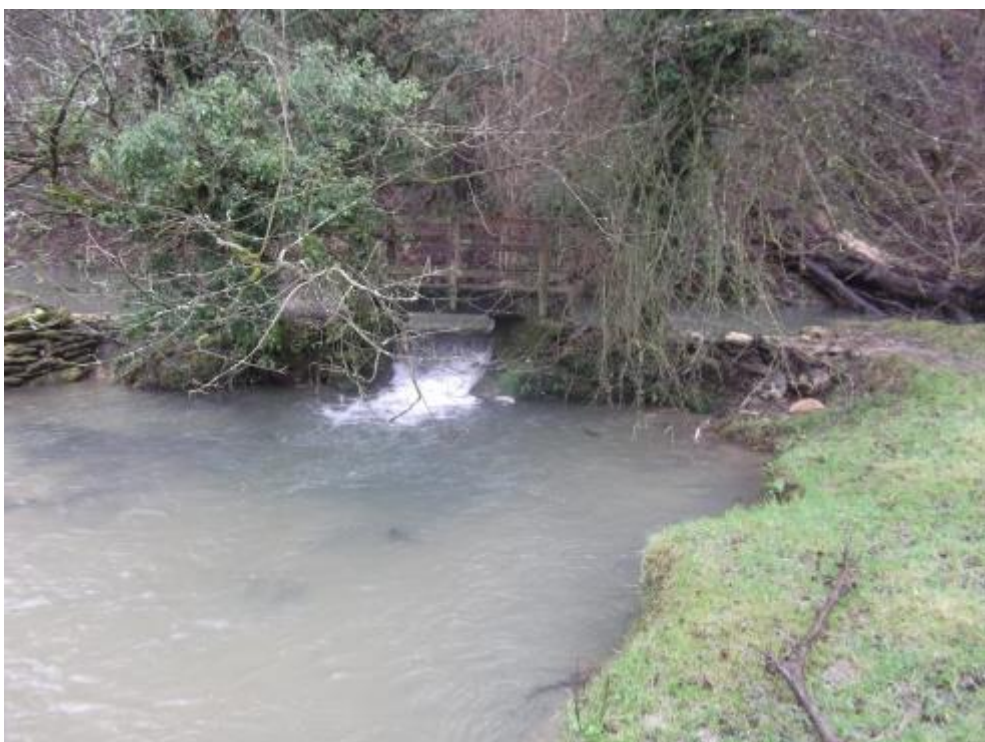
Table 29 Potential barriers to fish migration: Reach 3, NGR 384700,175651.

Project	By Brook catchment	River	By Brook
Reach Number	3	Recorder	MH
Date	08/01/2015	NGR	384700,175651
Category	E	Type	BAR-we
Description	Broad crested weir approximately 1.7m high and 2m wide.		
Land Use	LHB: Deciduous woodland	RHB: Improved/ semi-improved grassland	
Comments	<p>A broad crested weir of approximately 1.7m in height and 2m in width, situated upstream of Long Dean. The weir is only likely to be passable to migratory fish in high flows.</p>

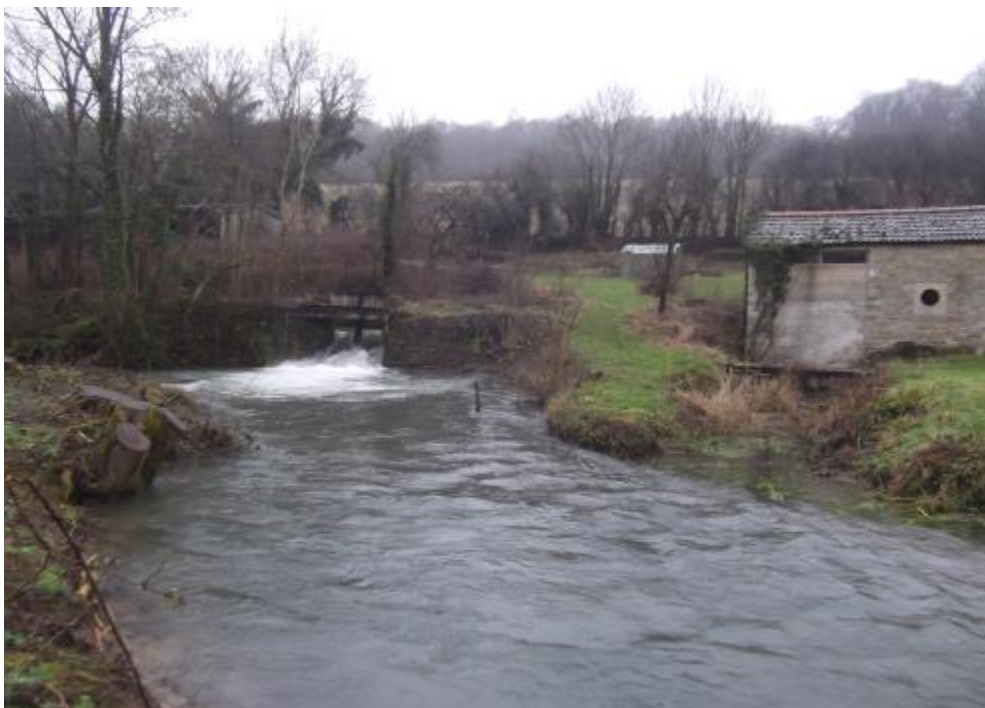
Table 30 Potential barriers to fish migration: Reach 3, NGR 384964,175683.

Project	By Brook catchment	River	By Brook catchment
Reach Number	3	Recorder	MH
Date	08/01/2015	NGR	384964,175683
Category	E	Type	BAR-we
Description	Straight drop weir approximately 4m high and 5m wide.		
Land Use	LHB: Improved/ semi-improved grassland	RHB: Improved/ semi-improved grassland	
Comments	<p>A straight drop weir of approximately 4m in height and 5m in width, situated at Long Dean Mill. The weir is unlikely to be passable to any migratory fish, even in high flows.</p>

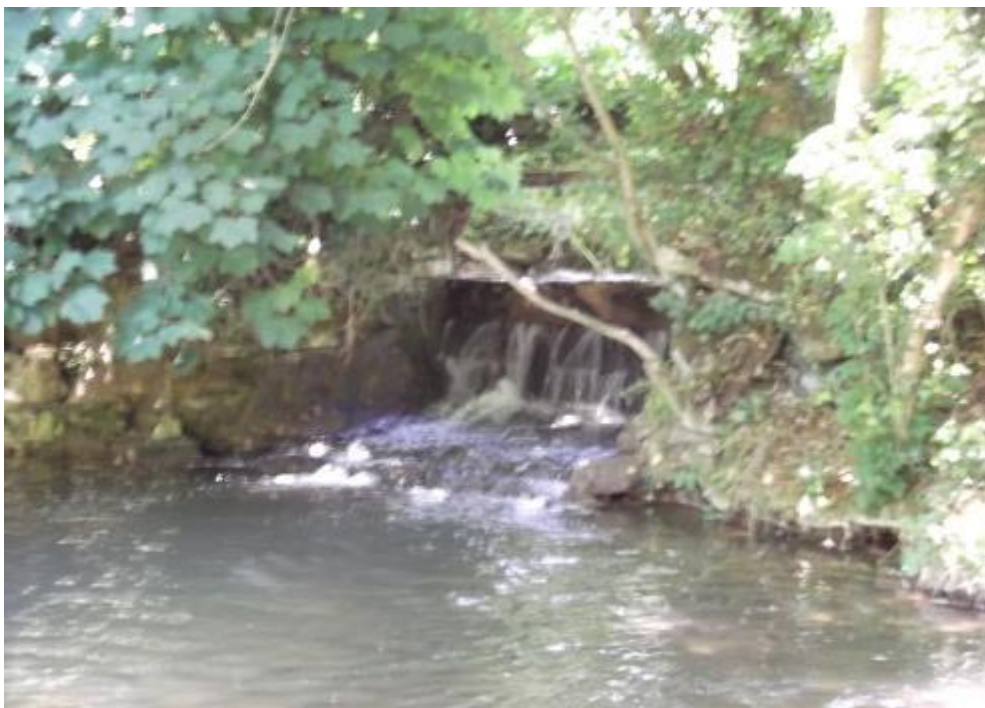
Table 31 Potential barriers to fish migration: Reach 3, NGR 385007,175532.

Project	By Brook catchment	River	By Brook
Reach Number	3	Recorder	MH
Date	08/01/2015	NGR	385007,175532
Category	E	Type	BAR-we
Description	Straight drop weir approximately 2m high and 2.5m wide.		
Land Use	LHB: Improved/ semi-improved grassland	RHB: Residential garden	
Comments	<p>A straight drop weir of approximately 2m in height and 2.5m in width, situated at Lower Long Dean Mill. The weir is only likely to be passable to migratory fish at moderate and high flows.</p>

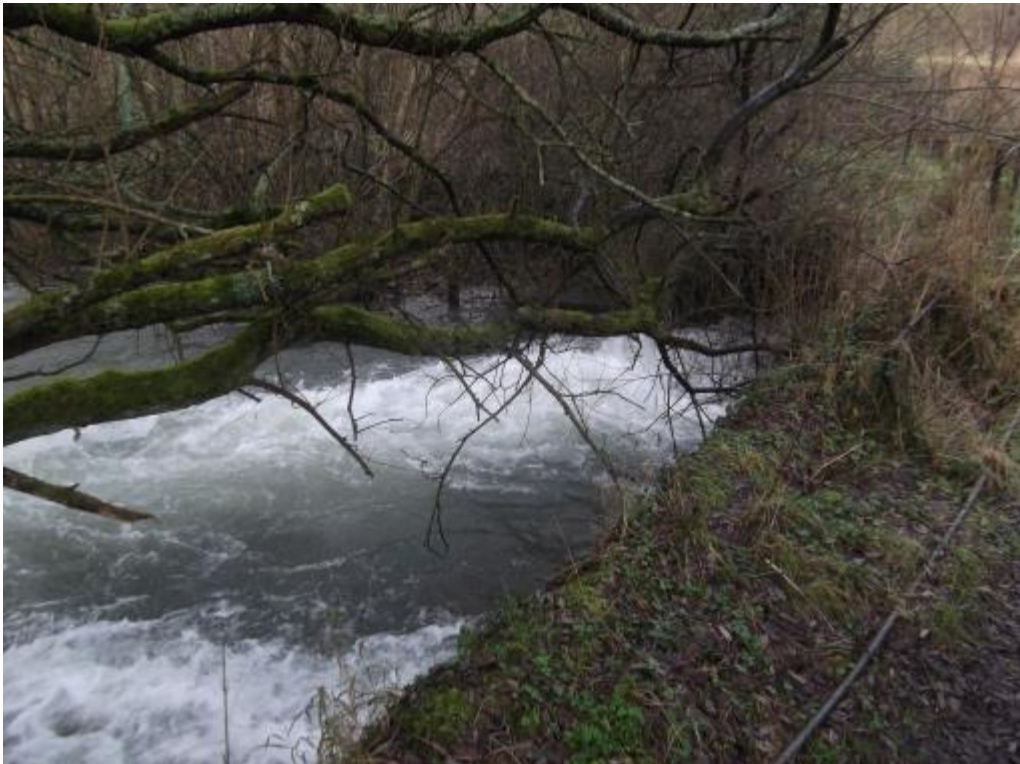
Table 32 Potential barriers to fish migration: Reach 5, NGR 379,833,167,429.

Project	By Brook catchment	River	By Brook
Reach Number	5	Recorder	MH
Date	02/02/2015	NGR	379833,167429
Category	E	Type	BAR-we
Description	Straight drop weir approximately 2m high and 4m wide.		
Land Use	LHB: Scrub/ Railway embankment	RHB: Scrub/ rank grassland	
Comments	<p>A straight drop weir of approximately 2m in height and 4m in width, situated downstream of Box Bridge. The weir is unlikely to be passable to any migratory fish.</p>

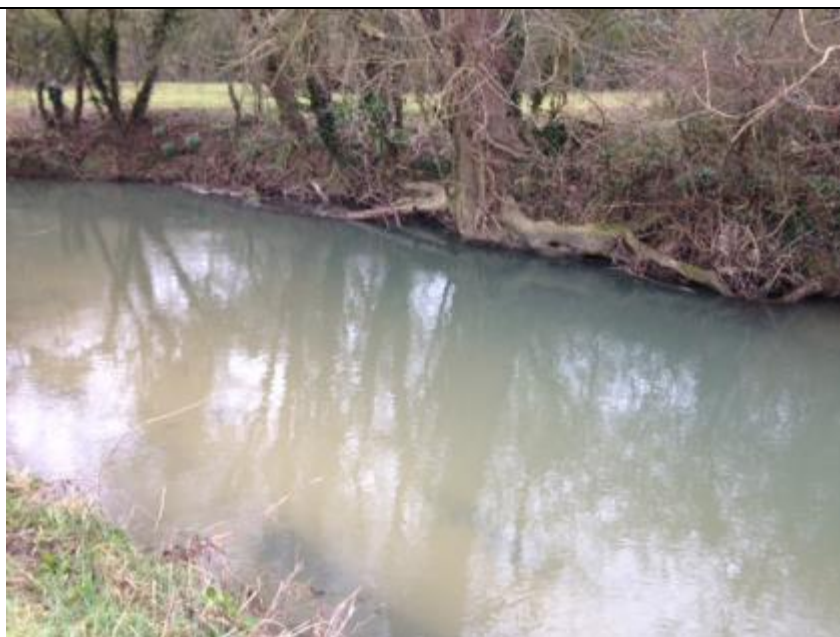
The substrate in Reaches 4a and the upstream section of Reach 5 are dominated by fine sediments and uniform bed conditions (**Figure 6**). The gravel supply in these areas is good since there is still a substantial amount of bank erosion processes occurring, particularly in periods of high flows and where the channel obstructions cause a restriction in flow and therefore increase erosional processes around the obstruction. It appears that there is sufficient material in the system (including in-situ material and sediment that is transported over these obstructions during high flows); however due to the size of the obstructions (four Grade 1 sources) the impact of these structures on the river is major and thus fine sedimentation is still occurring even during periods of high flows. This means that it is not possible to encourage further substrate recovery in these reaches through physical modifications to bed and bank form unless the obstructions were removed or altered in such a way as to substantially reduce the impounding effect they currently have on the river.

Figure 6 Large amounts of fine sediment are common throughout impounded reaches of the By Brook.

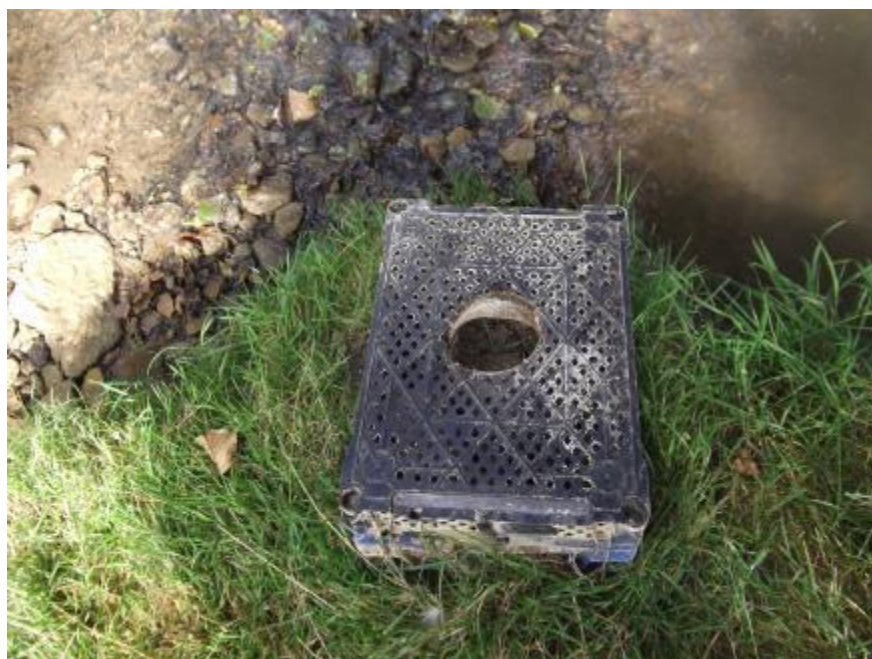
No invasive non-native species were observed during the walkover survey; however evidence of crayfish burrows were present on the Broadmead Brook. The presence of crayfish traps (**Figure 11**) at the side of the river and discussions with local residents are likely to suggest that the signal

Figure 11 Crayfish trap observed on the bank of the Broadmead Brook u/s of West Kington.
