Bristol Avon Rivers Trust

By Brook Catchment Fluvial Audit:

Source to confluence River Avon to include tributaries

March 2015

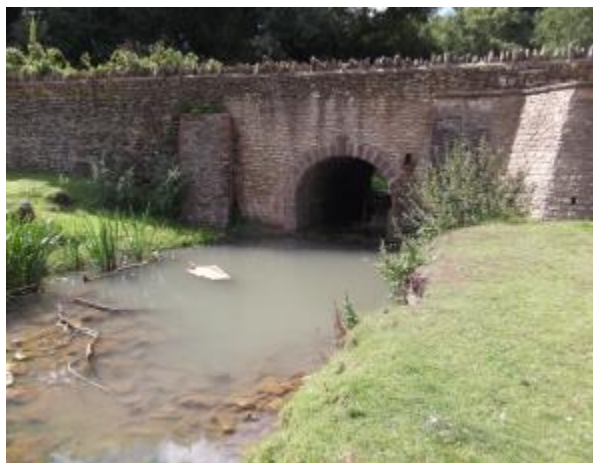
<p>A: Heavy siltation of substrate</p>

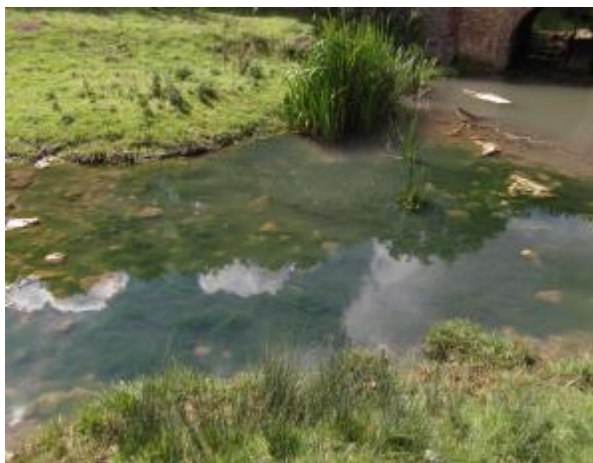
<p>B: Eutrophication and dense algal growth during summer</p>

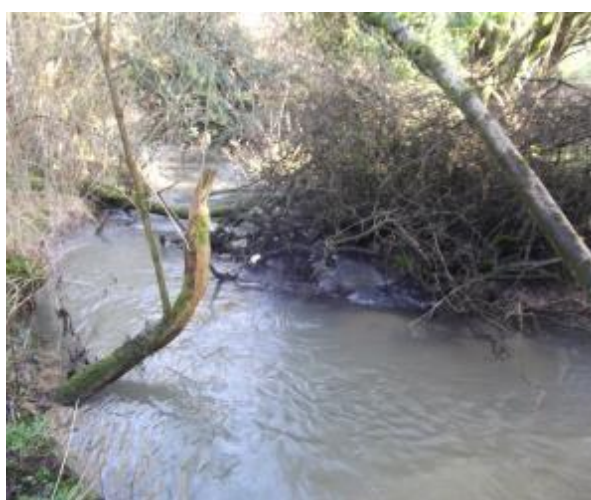
F: Good amounts of large wood debris

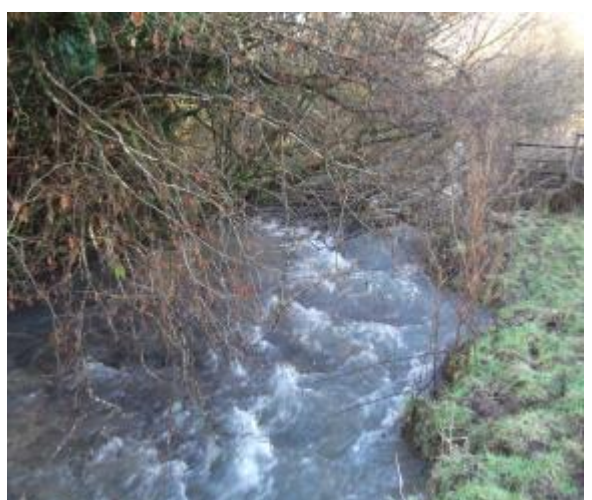
G: Good flow diversity

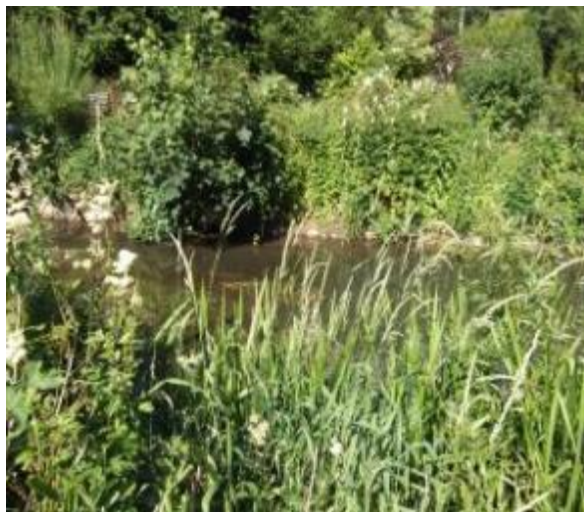
<p>A: Presence of diverse bank-side and emergent vegetation with in channel <i>Ranunculus</i>.</p>

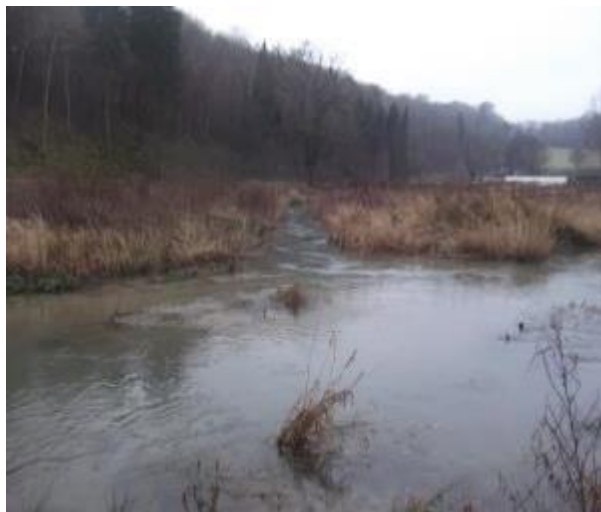
<p>B: The river is well connected to the floodplain.</p>

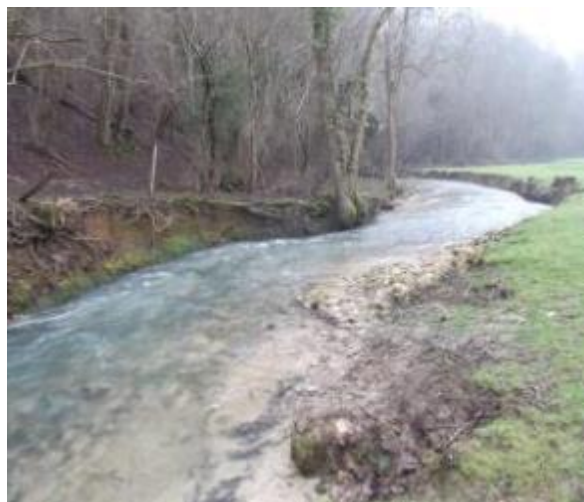
E: High energy gradient between Brook House and Lower Long Dean.

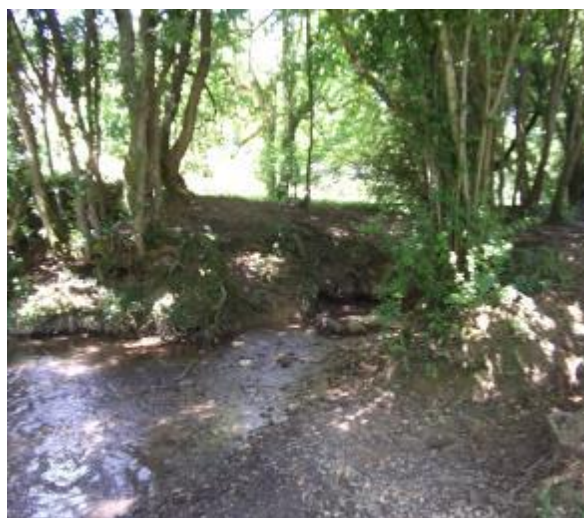
G: Predominant pebble, cobble substrate.

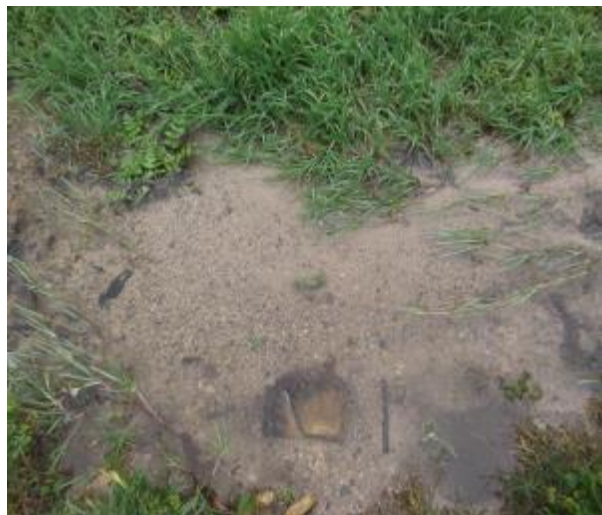
A: Clean gravels and other coarse substrate.

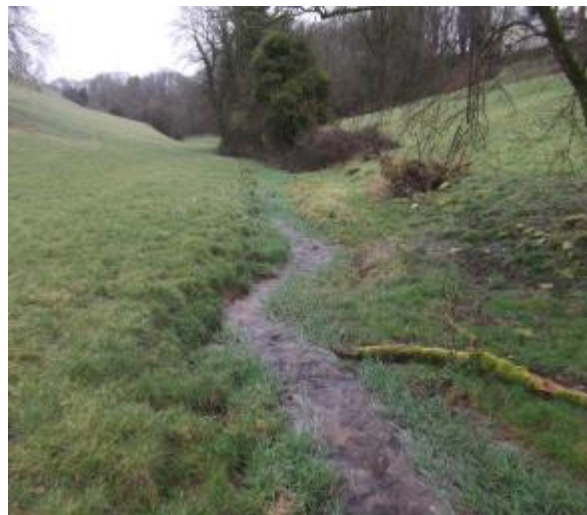
B: Low-intensity grazing in adjacent pasture.

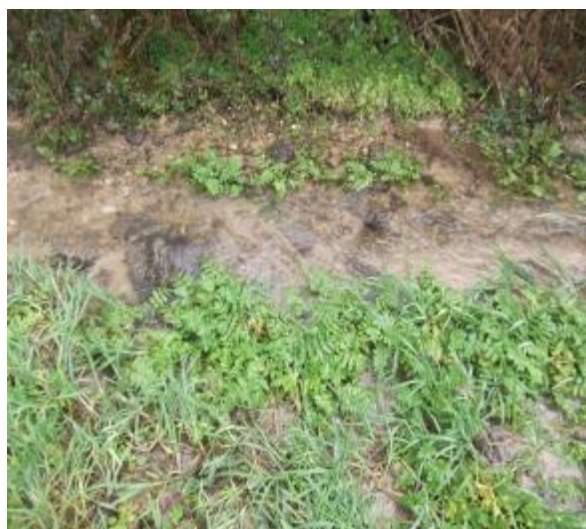
C: Good flow diversity and clean substrate provide good habitat for macrophytes and macroinvertebrates.

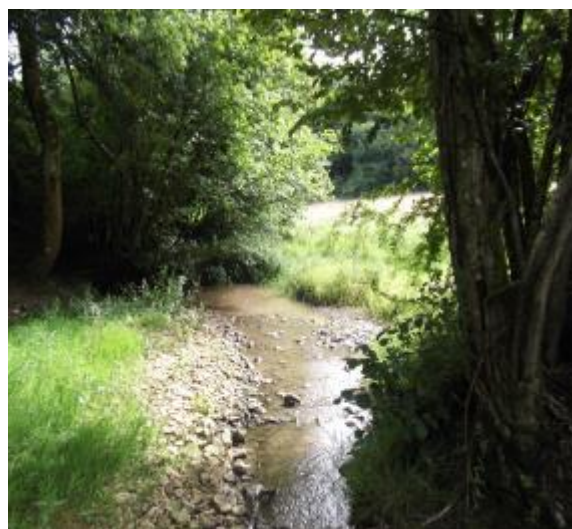
D: Shallow banks along the reach.

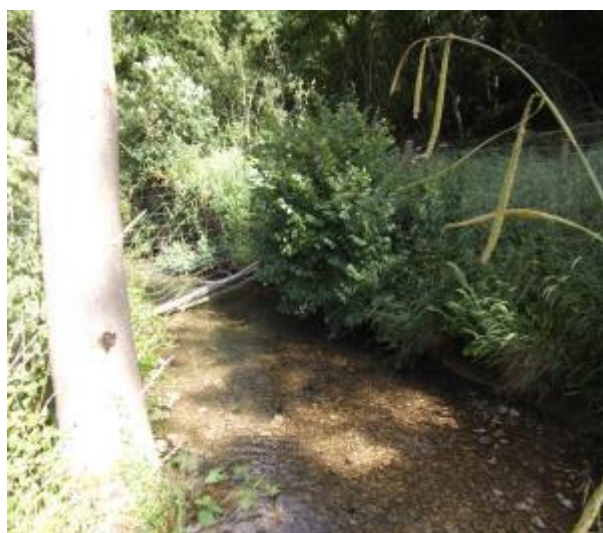
E: Pebble-cobble substrate.

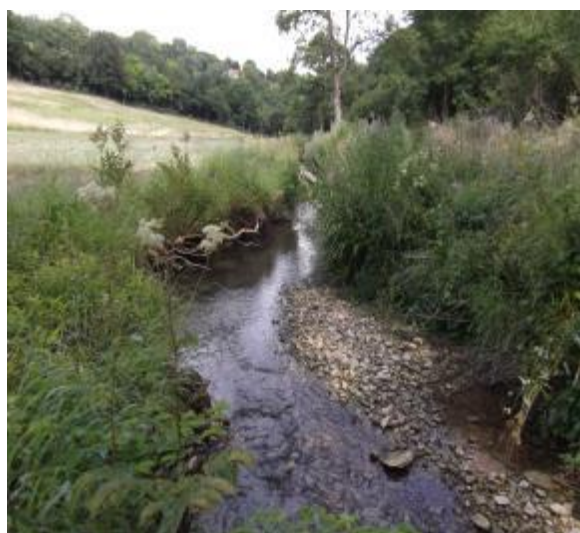
F: Open un-grazed areas support good riparian vegetation structure and diversity.

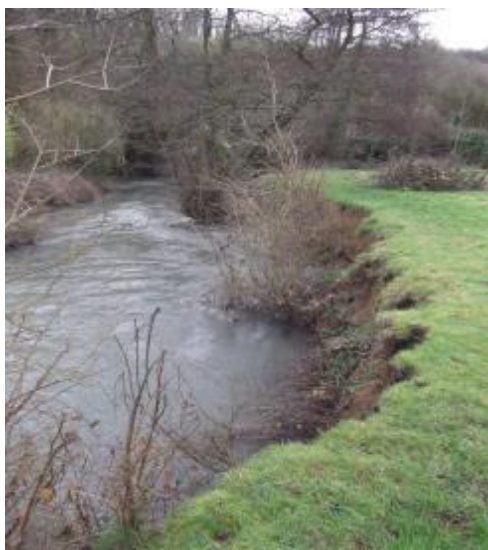
C: Bank erosion downstream on in-channel structures.

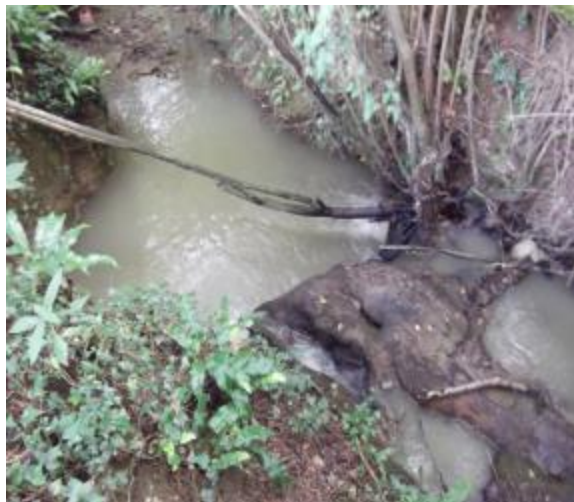
<p>A: Tree roots provide good habitat and flow diversity.</p>

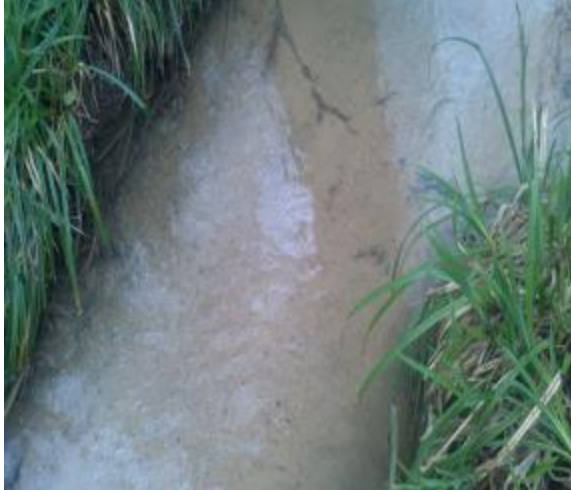
C: Sand and gravel substrate is dominant in the upstream section of the reach.

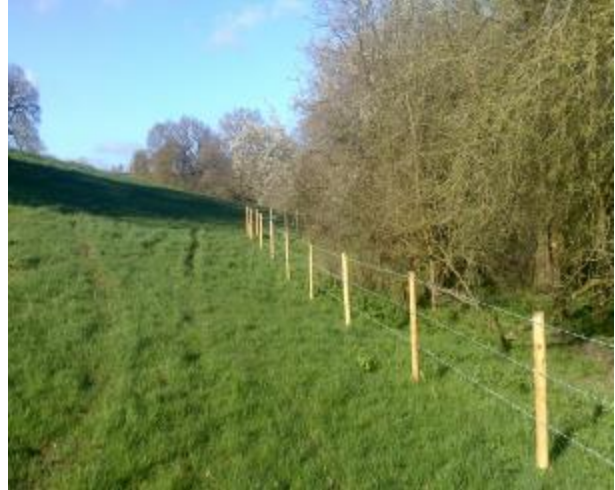
D: The installation of livestock fencing provides a good riparian buffer strip.

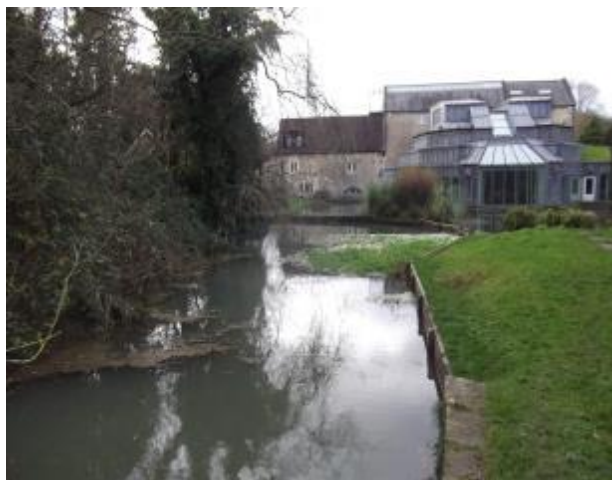
<p>A: Dominant glide flow and no perceptible flow in upstream sections of the reach.</p>

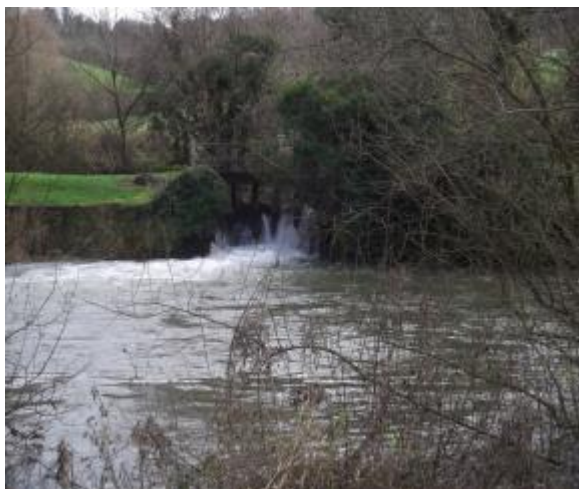
<p>B: In-stream structures.</p>

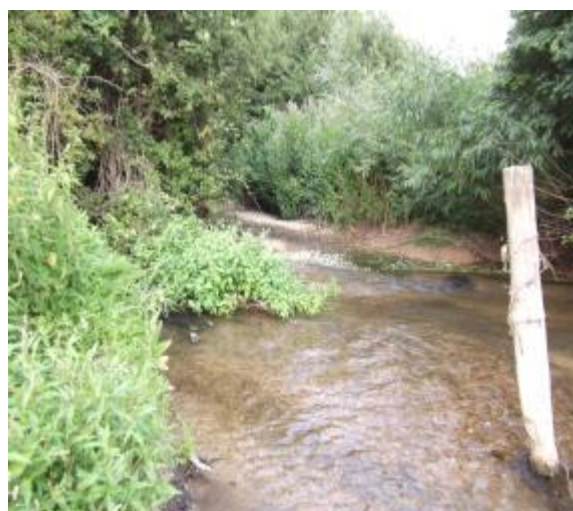
D: Clean spawning gravels in the middle section of Reach 5.

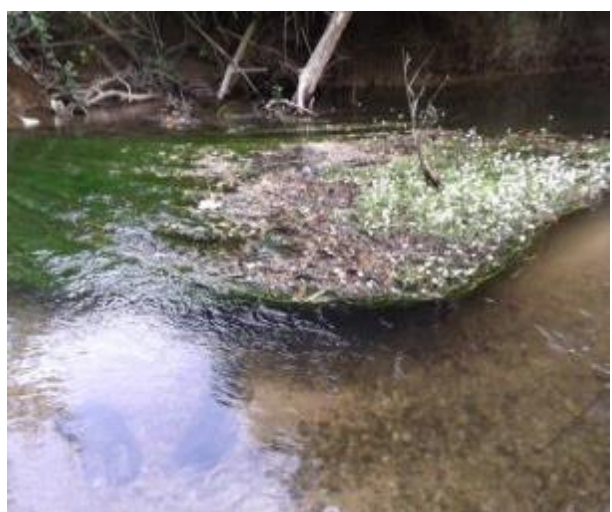
E: *Ranunculus* thrives in areas of open shallow water.

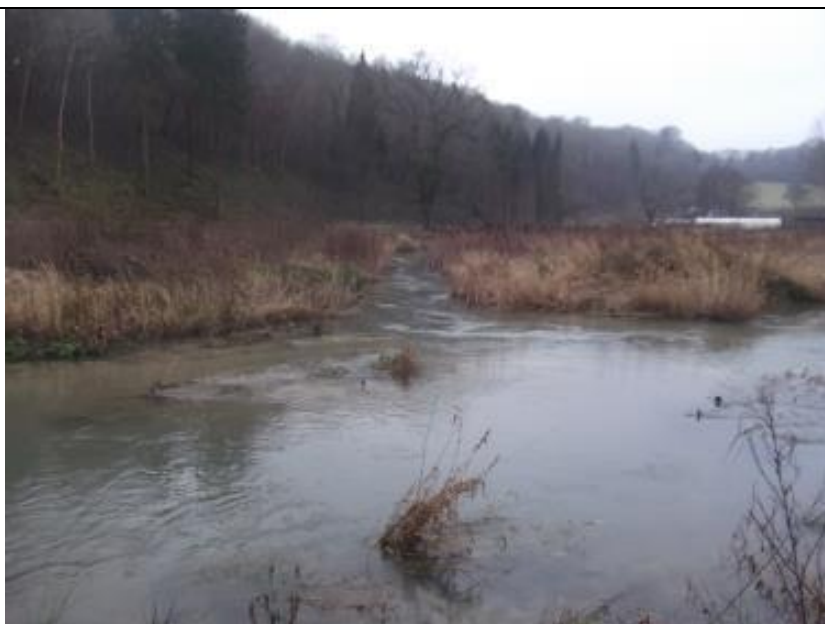
Figure 7 Braided river and wetland features at Colham Mill.

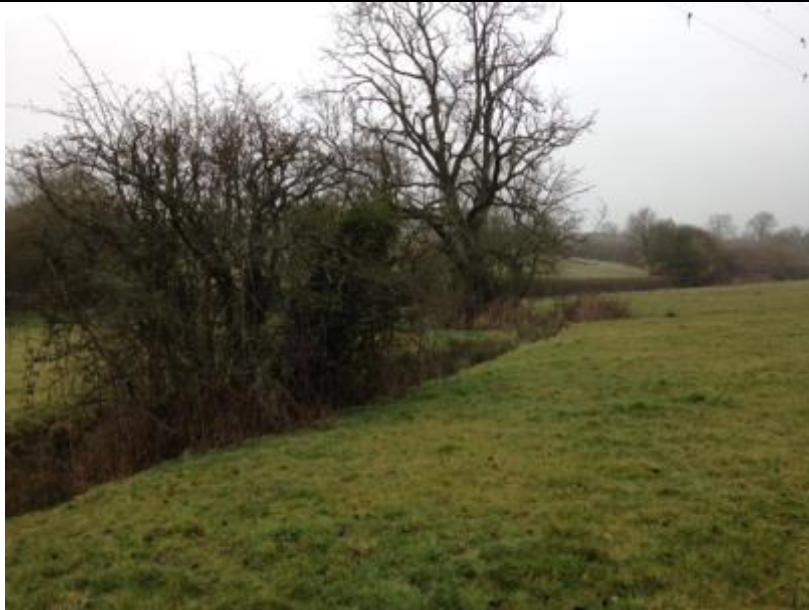
Figure 8 Spring-fed paleochannel flows along the field boundary near Box Mill Studio's.

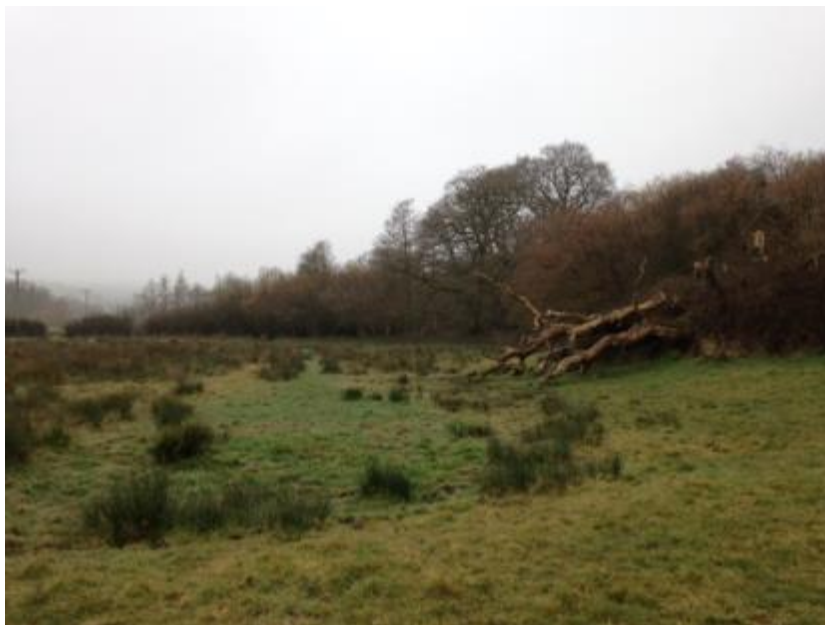
Figure 9 Floodplain wetland habitat upstream of Box Mill Studio's.

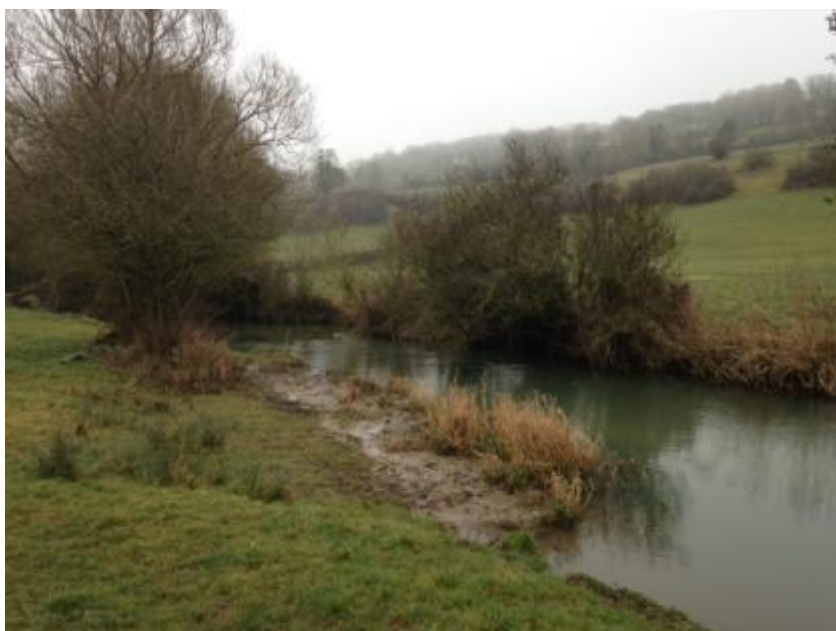
Impoundment by in-channel structures is a major issue in through Reaches 4a and Reach 5, which is concurrent with enlarged sections of the river and subsequent reduction in flow velocity resulting in notable sections of the river with no perceptible flow. Evidence of channel recovery is present at a number of locations within Reaches 4a and 5 where wide vegetated berms have established (**Figure 10**). There is also a dominance of large woody debris throughout the catchment; however, there are only a few occurrences where these cause natural impoundment of the waterbody and are therefore likely to be providing a wealth of valuable habitat for fish and macroinvertebrates as well as aiding variation in flow velocity.

Figure 10 Vegetated berm formation as the river tries to recover into a more natural channel.
